Drainage Report

Kimberly Clark
Northfleet Mill
Gravesend
Kent
DA11 9AD

A60790 Kimberly Clark Northfleet Mill DA11 9AD - CCTV Survey Report : 28/07/23

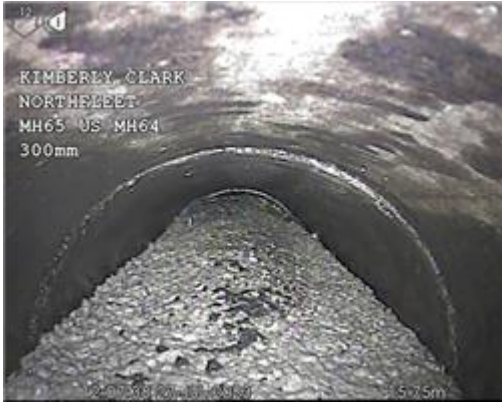
Pos	Video Ref	Code	Description	Image
00.00m		MH	Start node type, manhole MH65	
00.00m	0:00:00	WL	Water level: 5% Height/Diameter	
15.75m	0:01:07	OB	Other obstacles: 100% Cross sectional area loss - Severity 3 Concrete.	Image Provided - Ref: 0_2

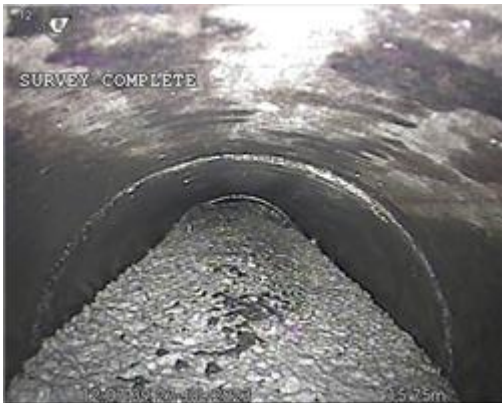
Section: 1 From: MH65 To: MH64	<ul style="list-style-type: none"> • Survey abandoned @ 15.75m due to concrete in line. • Line believed to be a redundant overflow no longer in use. Capped off with concrete. 	DRB Grade: B Pipe Size: 300 Material: Vitrified Clay (i.e. all clayware) Use: Surface Water
MH		
Section: 2 From: MH65 To: MH66	<ul style="list-style-type: none"> • No structural or operational defects found. Line clear & free flowing. 	DRB Grade: A Pipe Size: 300 Material: Vitrified Clay (i.e. all clayware) Use: Surface Water
MH		
Section: 3 From: MH65 To: ACO	<ul style="list-style-type: none"> • Longitudinal crack at joint observed at 0.00m. • Circumferential crack observed @ 4.67m. • Pipe in extremely poor condition from 5.40m-6.70m with multiple cracks and open fractures observed. Risk of total collapse if line not repaired. • Recommend structural lining of 6.70m 225Ø pipe. 	DRB Grade: C Pipe Size: 225 Material: Vitrified Clay (i.e. all clayware) Use: Surface Water

15.75m		SA	Survey abandoned Survey abandoned due to concrete in line.	Image Provided - Ref: 0_9999

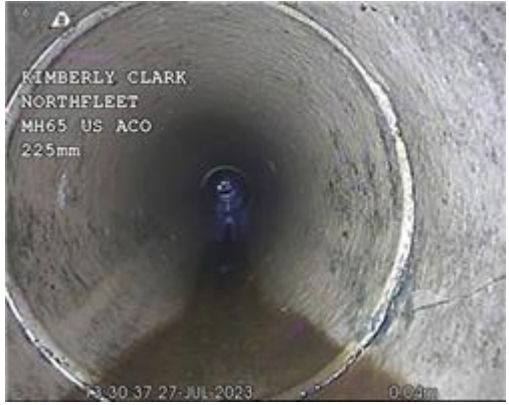
Pos	Video Ref	Code	Description	Image
00.00m		MH	Start node type, manhole MH65	
00.00m	0:00:00	WL	Water level: 0% Height/Diameter	
00.00m	0:00:07	CLJ	Crack, longitudinal at 05 o'clock at joint - Severity 1	Image Provided - Ref: 2_2

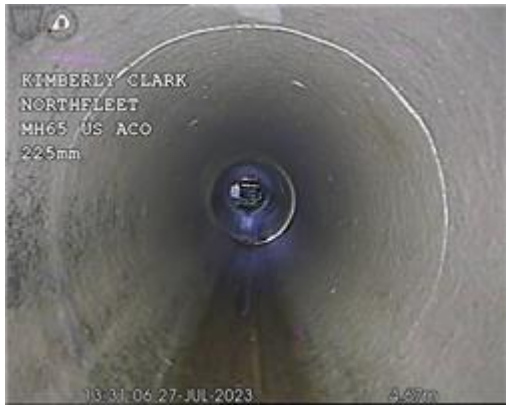
04.67m	0:00:37	CC	Crack, circumferential from 12 o'clock to 12 o'clock - Severity 1	Image Provided - Ref: 2_3

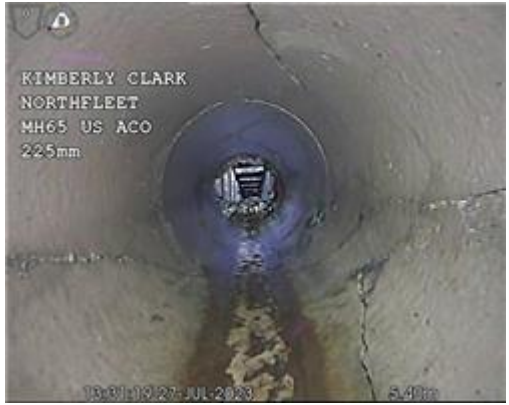
Pos	Video Ref	Code	Description	Image
05.40m	0:00:49	B	Broken pipe from 12 o'clock to 12 o'clock - Severity 4	<p>Image Provided - Ref: 2_5</p>

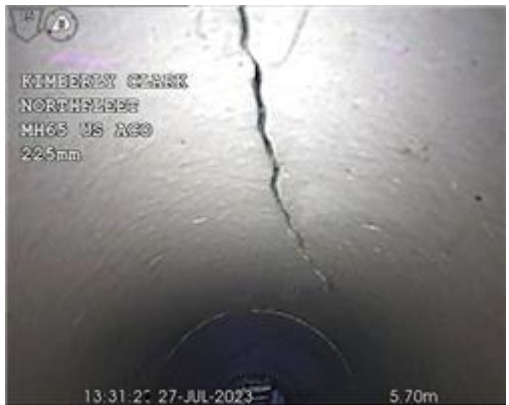
05.70m	0:00:51	REM	General remark Open fracture in crown of pipe.	<p>Image Provided - Ref: 2_6</p>

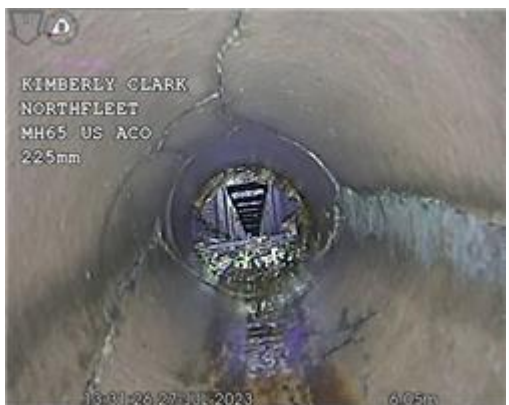
06.05m	0:00:57	B	Broken pipe from 12 o'clock to 12 o'clock - Severity 4	<p>Image Provided - Ref: 2_7</p>

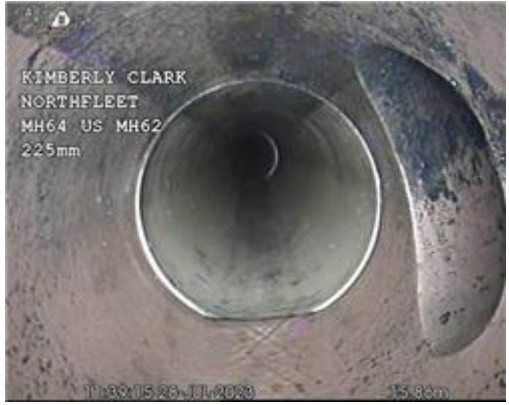
Pos	Video Ref	Code	Description	Image
00.00m		MH	Start node type, manhole MH64	
00.00m	0:00:00	WL	Water level: 5% Height/Diameter	
15.86m	0:01:25	JN	Junction at 03 o'clock: 150mm Diameter	Image Provided - Ref: 10_2

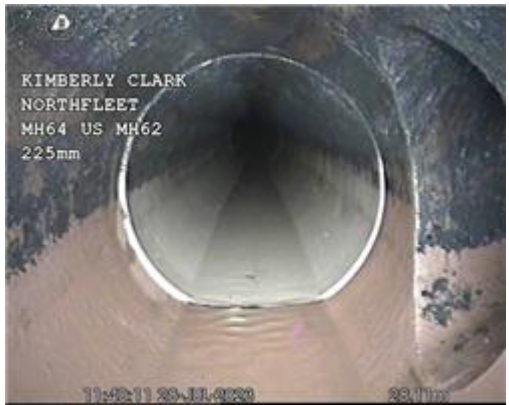
28.11m	0:02:22	JN	Junction at 03 o'clock: 150mm Diameter	Image Provided - Ref: 10_3

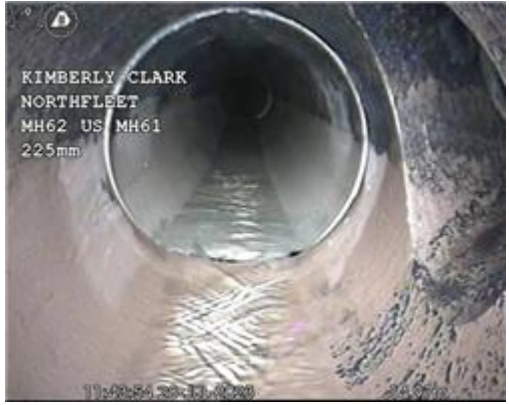
Pos	Video Ref	Code	Description	Image
00.00m		MH	Start node type, manhole MH62	
00.00m	0:00:00	WL	Water level: 5% Height/Diameter	
14.97m	0:01:17	JN	Junction at 03 o'clock: 150mm Diameter	Image Provided - Ref: 11_2

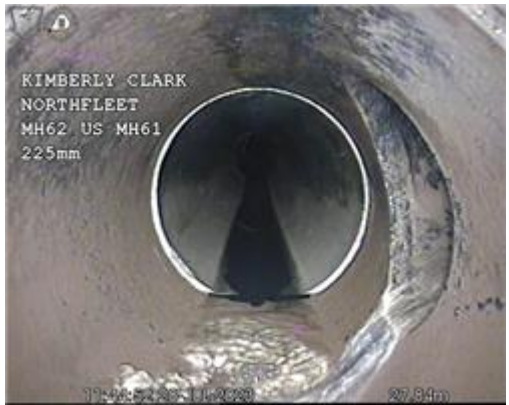
27.84m	0:02:15	JN	Junction at 03 o'clock: 150mm Diameter	Image Provided - Ref: 11_3

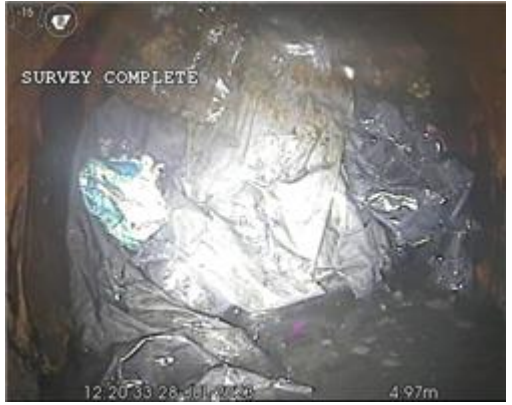
Pos	Video Ref	Code	Description	Image
00.00m		MH	Start node type, manhole MH64	
00.00m	0:00:00	WL	Water level: 0% Height/Diameter	
04.97m		SA	Survey abandoned Possible redundant line.	<p>Image Provided - Ref: 12_9999</p>

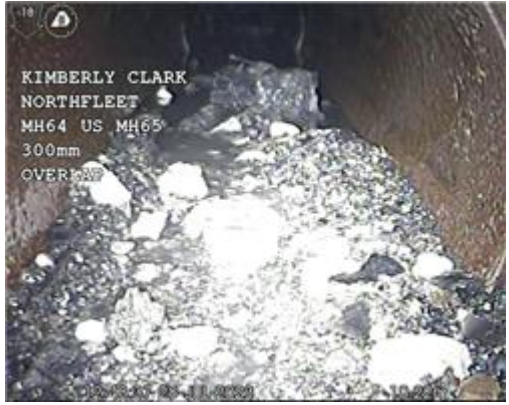
Pos	Video Ref	Code	Description	Image
00.00m		MH	Start node type, manhole MH64	
00.00m	0:00:00	WL	Water level: 10% Height/Diameter	
10.22m	0:00:51	DER	Settled deposits coarse: 25% Cross sectional area loss - Severity 3	Image Provided - Ref: 13_2

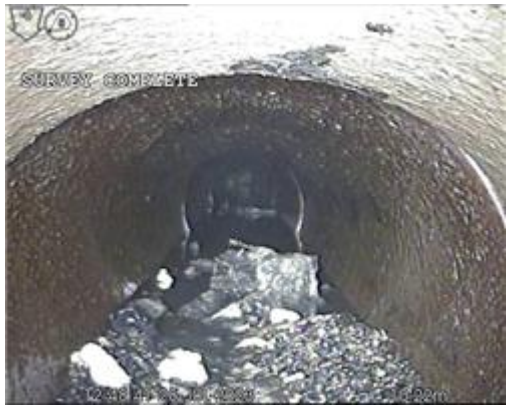
Section: 14 From: MH64 To: MH65	<ul style="list-style-type: none"> • Survey abandoned @ 10.22m due to rubble/debris. • Line believed to be a redundant overflow no longer in use. Capped off further D/S. 	DRB Grade: B Pipe Size: 300 Material: Vitrified Clay (i.e. all clayware) Use: Surface Water
MH

10.22m		SA	Survey abandoned Unable to complete survey due to rubble/debris.	Image Provided - Ref: 13_9999
