Drainage Report

Kimberly Clark
Northfleet Mill
Gravesend
Kent
DA11 9AD

A60790 Kimberly Clark Northfleet Mill DA11 9AD - CCTV Survey Report : 28/07/23

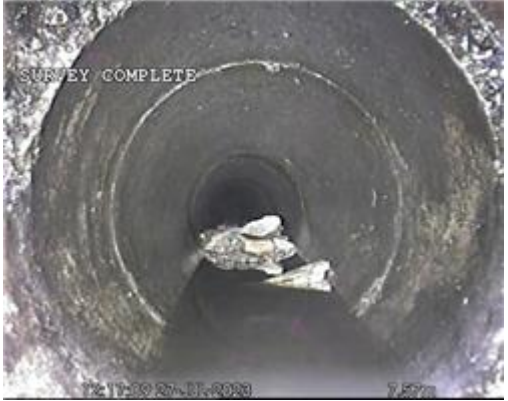
Section 2

Pos	Video Ref	Code	Description	Image
00.00m		MH	Start node type, manhole MH65	
00.00m	0:00:00	WL	Water level: 0% Height/Diameter	
07.57m		MHF	Finish node type, manhole MH66	<p>Image Provided - Ref: 1_9999</p>

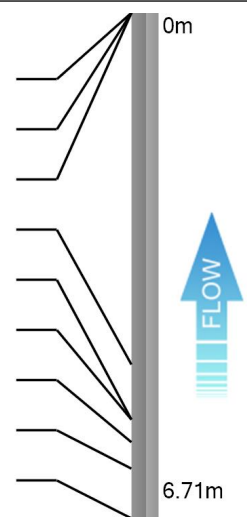
Position	Code	Description	CD	Pic	Video Ref	
00.00m	MH	Start node type, manhole				
00.00m	WL	Water level 0%			0:00:00	
00.00m	CLJ	Crack, longitudinal 05 at joint		2_2	0:00:07	
04.67m	CC	Crack, circumferential 12-12		2_3	0:00:37	
05.40m	CMJ	Cracks, multiple 12-12 at joint		2_4	0:00:43	
05.40m	B	Broken pipe 12-12		2_5	0:00:49	
05.70m	REM	General remark		2_6	0:00:51	
06.05m	B	Broken pipe 12-12		2_7	0:00:57	
06.71m	GYF	Finish node type Gully		2_99

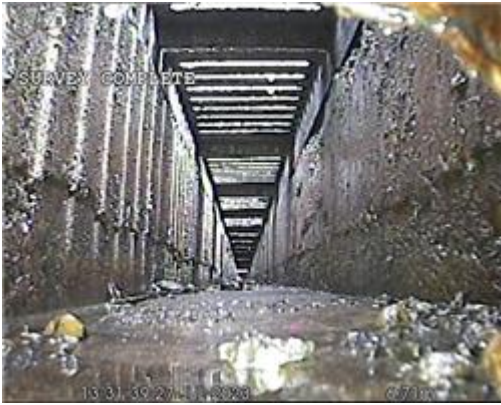
Pos	Video Ref	Code	Description	Image
06.71m		GYF	Finish node type Gully ACO	<p>Image Provided - Ref: 2_9999</p>

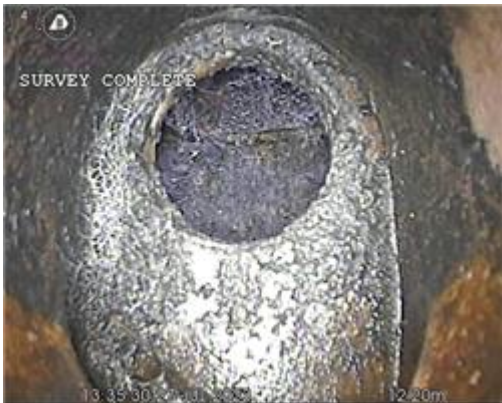
Section 4

Pos	Video Ref	Code	Description	Image
00.00m		MH	Start node type, manhole MH65	
00.00m	0:00:00	WL	Water level: 0% Height/Diameter	
12.20m		GYF	Finish node type Gully G50	<p>Image Provided - Ref: 3_9999</p>

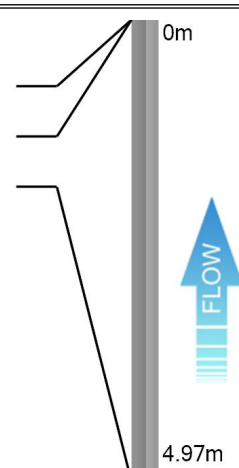
Position	Code	Description	CD	Pic	Video Ref	
00.00m	MH	Start node type, manhole				
00.00m	WL	Water level 0%			0:00:00	
04.97m	SA	Survey abandoned		12_9

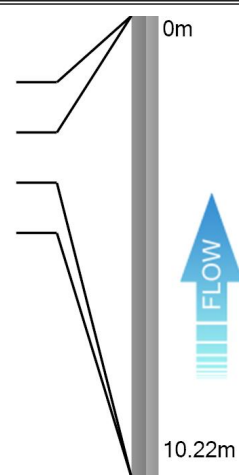
Position	Code	Description	CD	Pic	Video Ref	
00.00m	MH	Start node type, manhole				
00.00m	WL	Water level 10%			0:00:00	
10.22m	DER	Settled deposits coarse 25%		13_2	0:00:51	
10.22m	SA	Survey abandoned		13_9
